# First Utility-Scale BESS in Tuvalu & Solar Expansion in Funafuti & three Outer Islands

### Earth Faults in PV Systems: Identification, Safety, and Repair Strategies

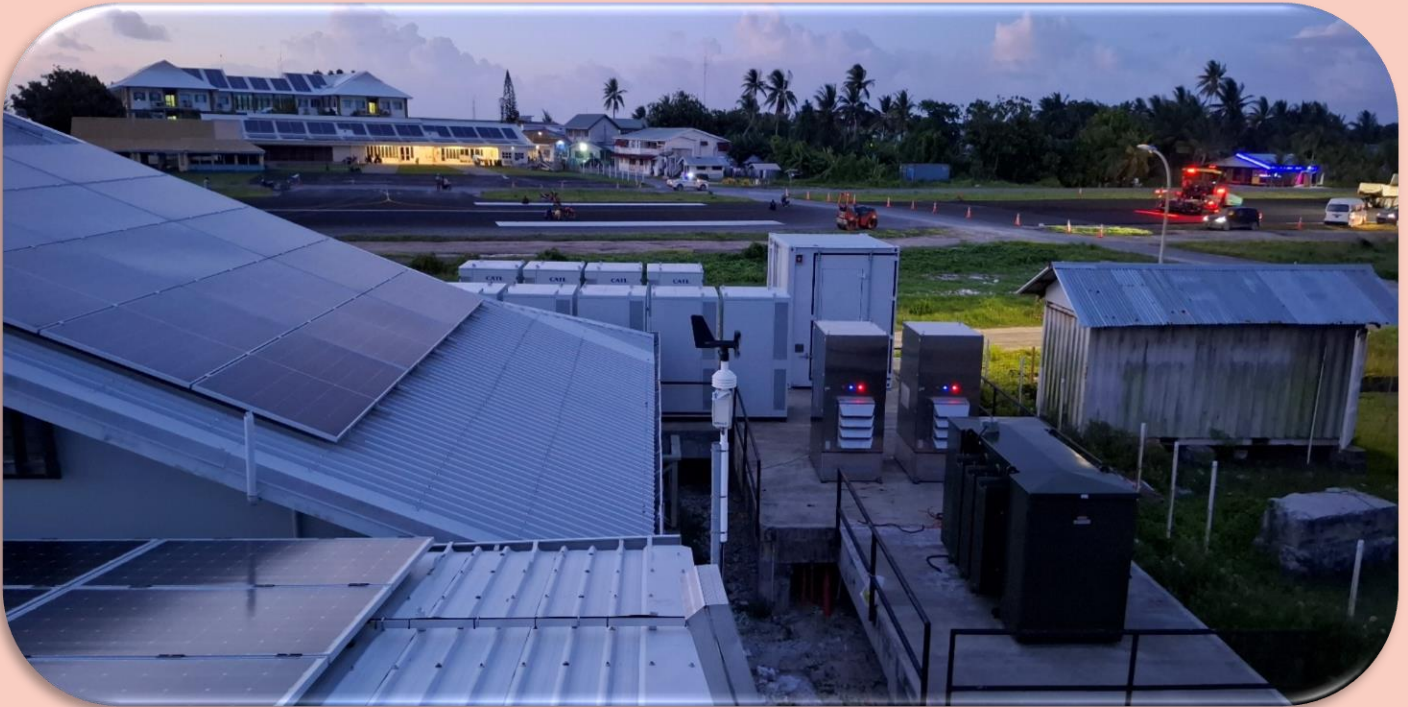
FUNAFUTI 3MW/3.35MWH BESS AT TEC POWERSTATION

Storage System (BESS) with a capacity of 3.0 MW / 3.35 MWh at the power station, integrated with its RMU and transformer.

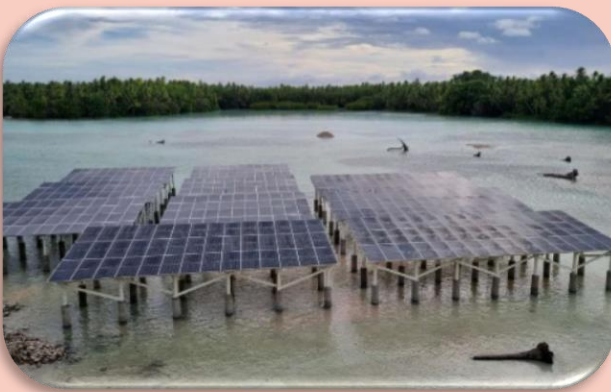
NUKUFETAU LAGOON SOLAR ARRAY

**Secondly, Nukufetau:** The PV system was enhanced to an overall capacity of 160.04kWp, with the addition of a 78.4kWp ground-mounted PV system within the lagoon. CBS also upgraded controls, communications, and the first distribution pillar.

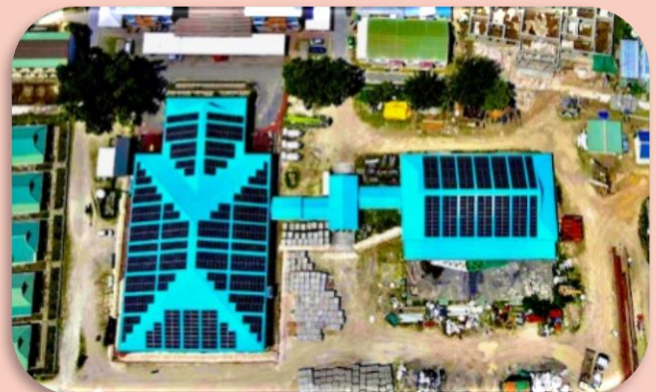
QEII PARK SOLAR ARRAYS

**Lastly, at Funafuti**, the largest and most complex site of the project, CBS Power Solutions successfully installed 500 kWp of solar PV arrays across three key building rooftops: TPCC, Tulakiga Hall, and Airport Terminal Services. Complementing this, CBS deployed a Battery Energy

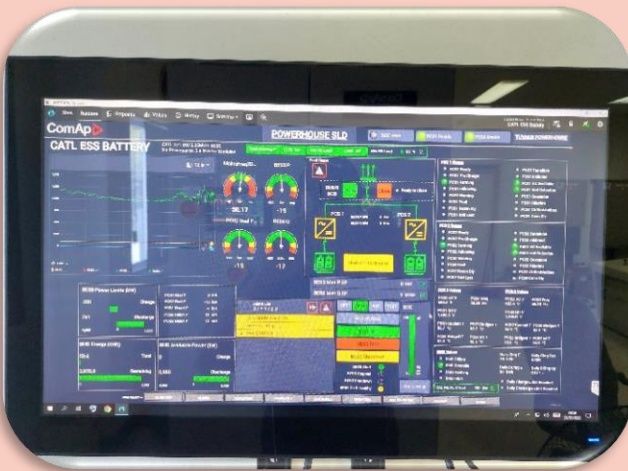
COMAP HMI DISPLAY AT TEC POWERHOUSE

Additionally, CBS integrated the BESS and PV systems with the existing 3 x 600 kW Medium Speed Daihatsu Diesel Generators, enabling fully automated operation. As part of this effort, CBS upgraded the entire power station's controls and SCADA system, streamlining operations and significantly reducing the operational burden

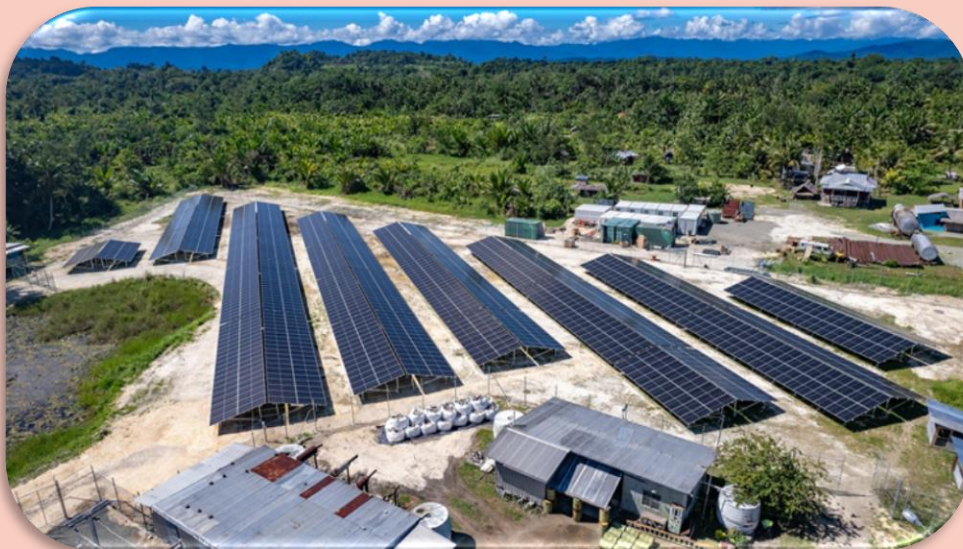
Aitape Solar Power Plant in PNG

Through Australian government support, PNG power has completed a new solar power plant in Aitape, West Sepik. The Aitape solar power plant took around 18 months to design and build, costing K18 Million. The solar plant comprises 784kW<sub>p</sub> solar PV array and 1MWh Battery storage to store energy generated during the day to supply power at night. The system will benefit the households connected to the PNG Power Ltd's grid in Aitape. There are

around 500 customers connected to the grid in Aitape comprising households, businesses, schools, health facilities and government buildings.

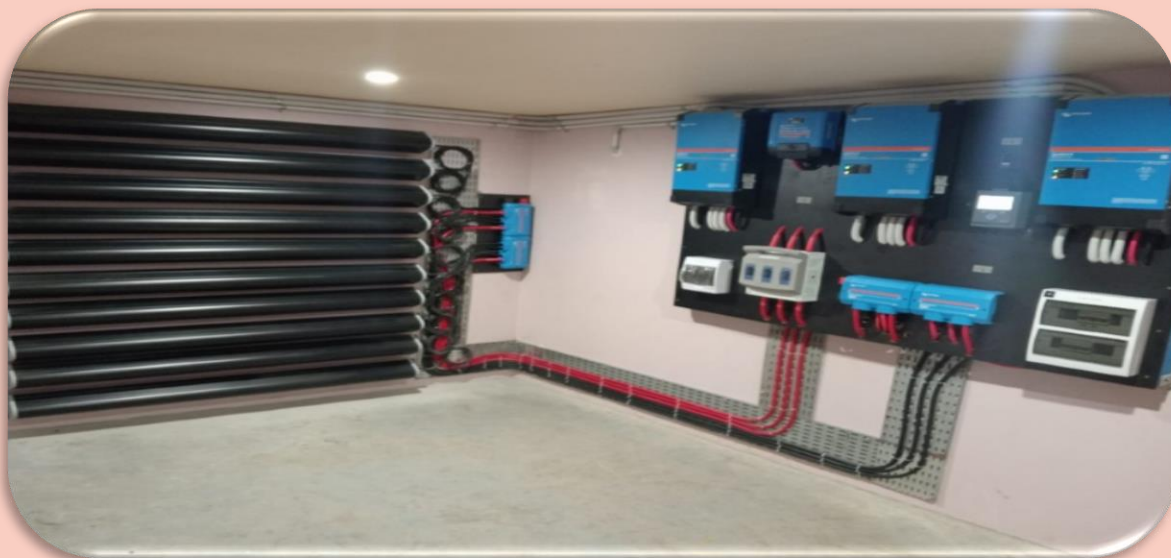
Solar Fiji successfully designed and installed a Victron Energy hybrid solar system for Out of the Blue Resort, an eco-conscious beachfront property in Fiji. This innovative system provides the resort with a reliable and efficient renewable energy solution, reducing its dependence on traditional diesel generators while ensuring a continuous power supply for guests and operations.

The system features high-performance solar panels, advanced lithium battery storage, and an intelligent Victron Energy power management system. This combination allows for seamless integration of solar energy, ensuring maximum efficiency by prioritizing solar power usage and only utilizing the backup

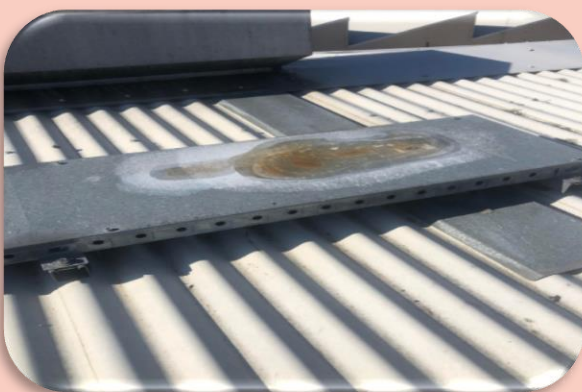
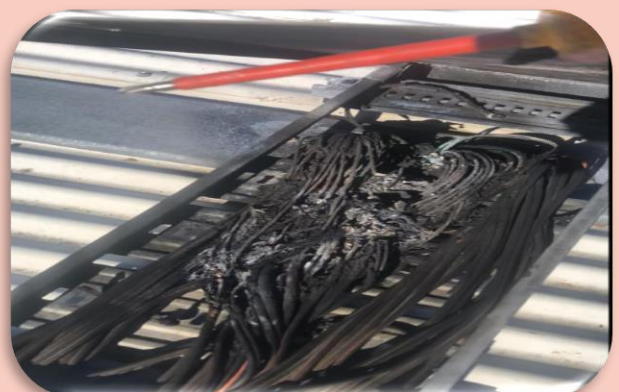
It should be noted that earth faults are ALWAYS a problem. Earth faults are often ignored because they may be intermittent and the system may be performing as expected and visual inspection may not reveal any issues. However, even if the earth fault is small, this earth leakage could damage components over time, the fault could propagate into a larger issue and in worst case scenarios, create live exposed metallic parts or create fires. The image below (left) shows corrosion due to an earth fault. The earth fault caused an arc which damaged the wire tray, and burnt many of the wires (right) severely decreasing site production. To avoid this, earth faults should ALWAYS be investigated.

- Installation errors like pinched wires, wires damaged during installation, or wires secured too close to a racking edge
- Thermal expansion and contraction
- Wind motion that causes wiring to rub against the module frames, conduit, or racking, causing wear on the insulation

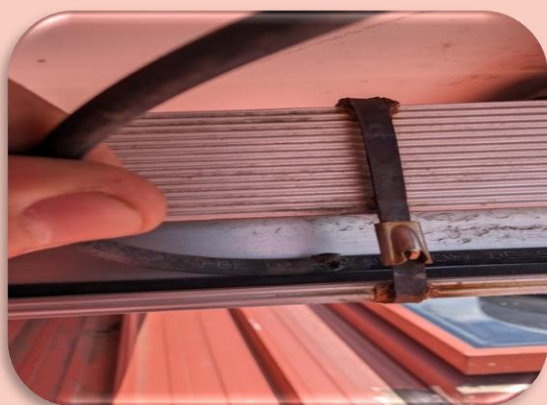
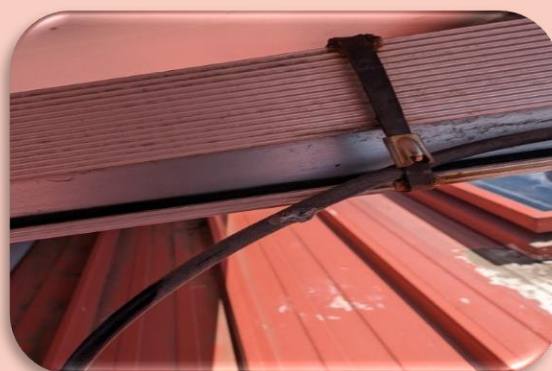
and adhered to during the works. The photos below show an intermittent earth fault caused by a small nick in a panel cable.

Once you've found the earth fault, the next step is to repair it by replacing the affected conductor or module.

If the damaged conductor is in conduit or free air, you can replace it with a new, undamaged conductor. A single conductor in a conduit with other conductors may be challenging to replace without removing all conductors from the conduit.

If the conductor is a lead to a PV module, you might try to bypass the affected module until a replacement module can be found. Alternatively, you may replace the lead yourself however you must verify that this does not affect the workmanship or performance warranty of the module.
